# **Environmental results from supplementary soil study at Kvål, Sandnes**

**Ecofact rapport: 823**

As a part of an environmental due diligence Ecofact has been engaged by Teknaconsult to perform a supplementary environmental soil study at Kvål, in Sandnes municipality. The area under investigation is a part of Kvål Næringpark, and consists of subfields IL4a, IL4b, IL5, N4. Parts of the property has been investigated for soil contamination previously because of historical dumping of waste, with results showing that two of the 18 points contained high concentrations of benzene. To find out whether the surrounding areas were also contaminated, additional soil sampling was conducted. This report contains a description of the field work and the analytical results from the latest environmental soil study.

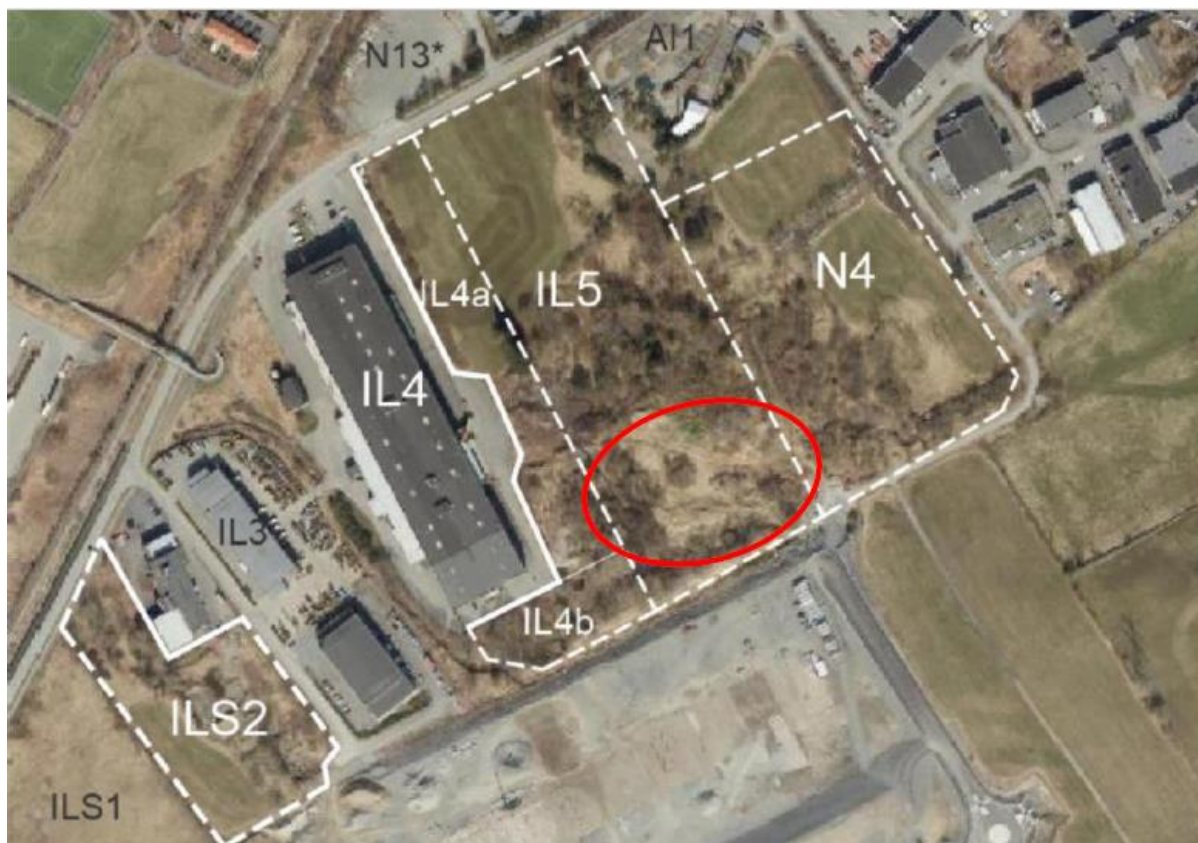
Figure 1. Kvål Næringspark consist of several subfields. It is subfield IL4a, IL4b, IL5 and the northern half of N4 that is included in this survey. The area that was investigated in the preliminary soil study (Samuelsen, 2020) is marked with a red circle. The figure is taken from Samuelsen, 2020.

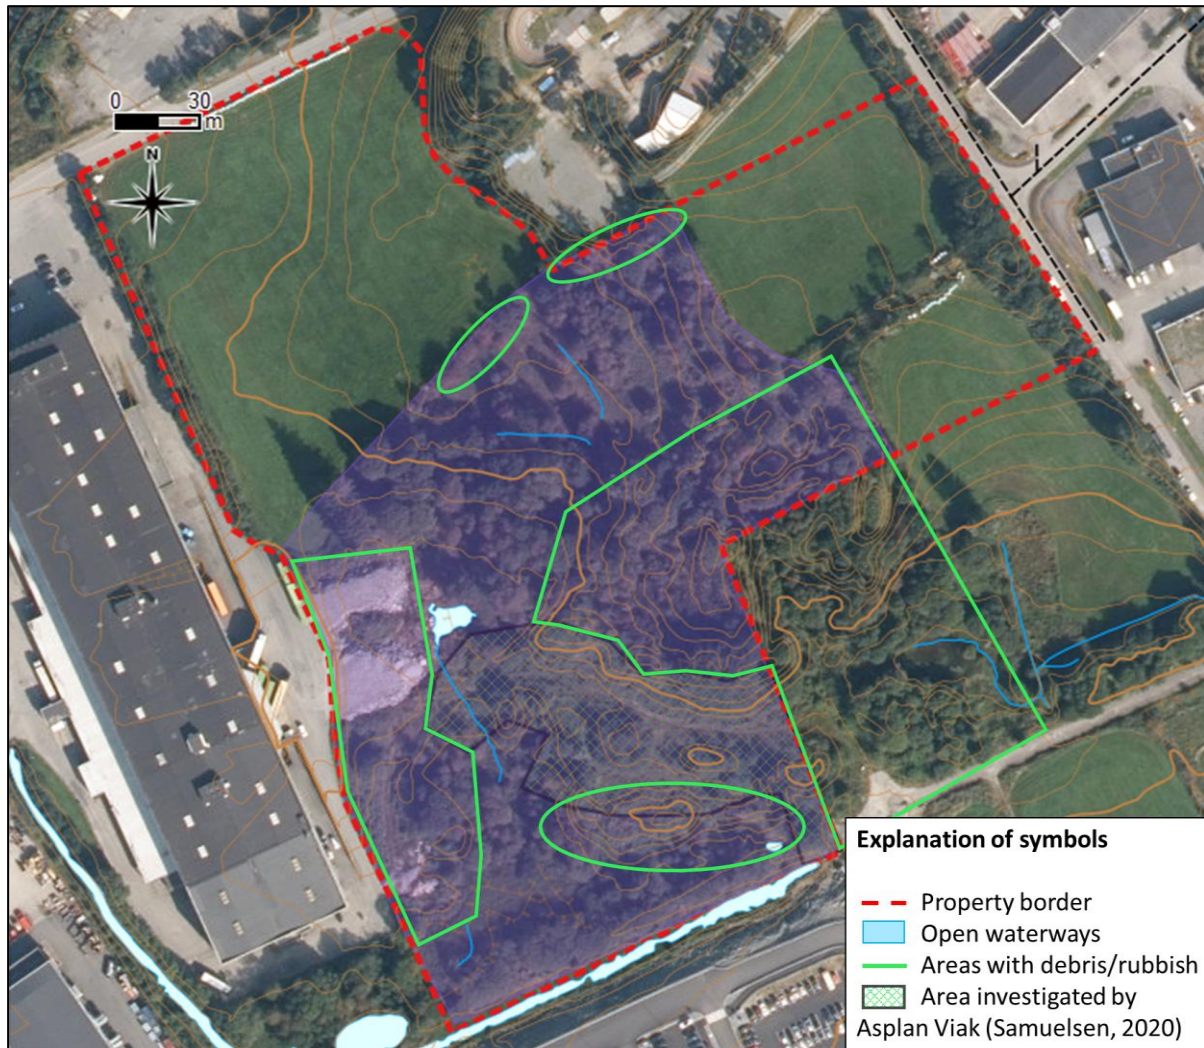
Figure 4. The properties area that was suspected to possibly be contaminated is marked in purple (rough delineation).

The southernmost sample area consisted of a landfill with rocks and bricks. Unnatural elevations are found in the terrain, and the visible garbage indicated that contamination could be expected several places on the property. A total area of about 18 000 m<sup>2</sup> showed signs of unnatural mass deposition or littering, including the area Asplan Viak surveyed in 2020.

One should expect to find rubbish in the ground under the unnatural elevations in the terrain, and/or next to visible rubbish (point 8 to 15, and areas marked in figure 4). Rubbish needs to be taken care of, sorted, and delivered to a waste disposal if needed. Also, if hazardous waste, or shiny, smelly soil is found, an environmental consultant must be contacted, in order to test and clarify whether the soil is contaminated.
